**Flood Control Project Maintenance
Levee Inspections**

Maintenance Issue Types Only, Levee Inspection Report By Mile - Fall 2014

Madera County FCWCA

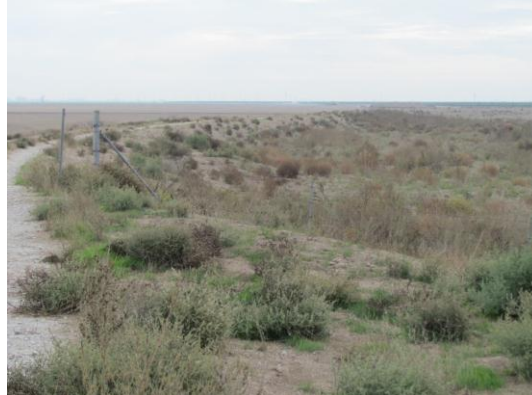
Photo 1 of 1 : FA_2014_NA0011_146_40_20141121_00010.jpg

| Control annual grass and weeds on the levee slopes and easements. Inspector Comments: There has been some vegetation removed from waterside slope either by sheep or goat but tumble weeds have regrown on levee slope. | | | | | |

Looking downstream from levee mile 0.03 waterside.

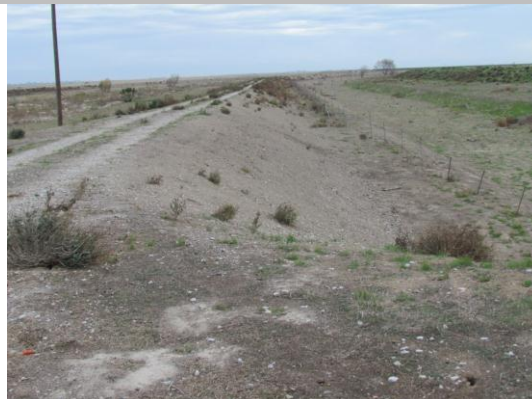
Photo 1 of 1 : FA_2014_NA0011_147_24_20141121_00012.jpg

| Inspector Comments: Remove the unwanted weeds from the levee slope. | | | | | |

Looking upstream from landside slope 0.00 to 3.51.

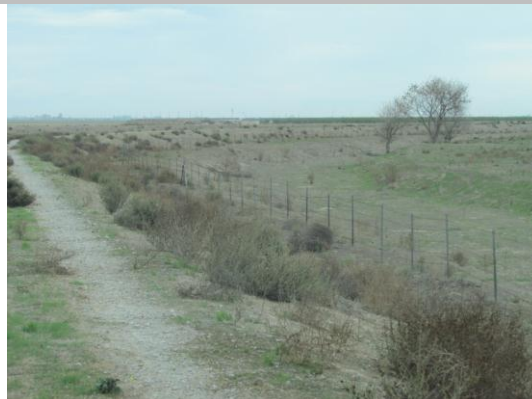
Photo 1 of 1 : FA_2014_NA0011_147_45_20141121_00013.jpg

| Control annual grass and weeds on the levee slopes and easements. Inspector Comments: Remove tall weeds from landward levee slope. | | | | | |

Looking upstream from levee mile 0.08 to 0.87.
